PROTECTED LEVEL CROSSING RISK ASSESSMENT

Anglia Route
Level Crossing Narrative Risk Assessment
Meldreth Road AHB
Planned 9th May 2022

This is a risk assessment for Meldreth Road AHB level crossing.

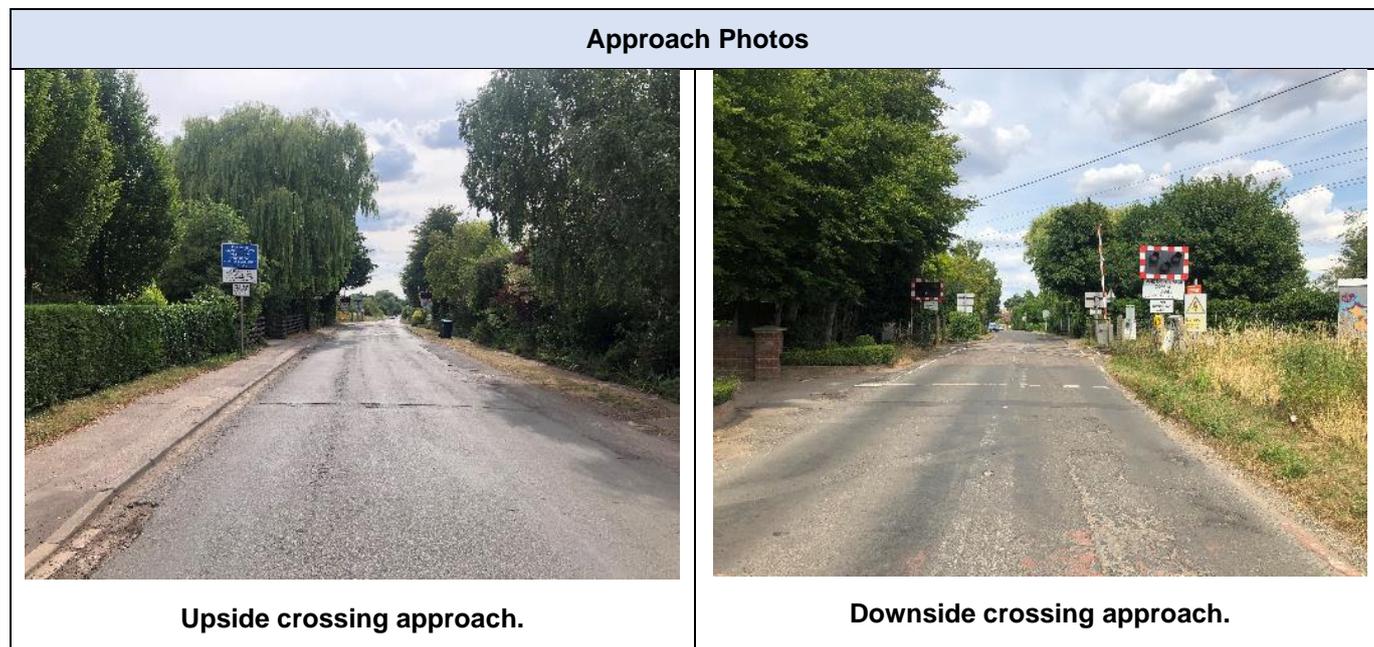
1.3 ENVIRONMENT

The road approach speed is estimated to be 30 to 40mph.

It is a Public Highway level crossing.

At Meldreth Road AHB level crossing the orientation of the road/path from the north is 65°; the orientation of the railway from the north to the up line in the up direction is 210°.

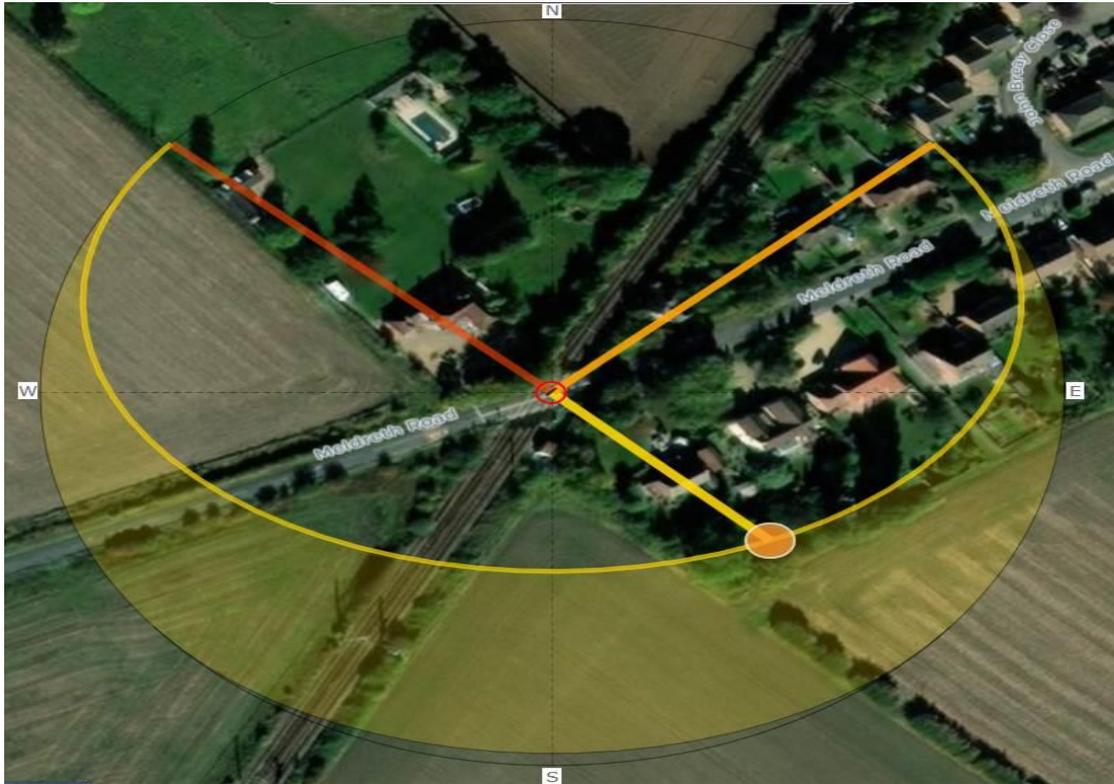
Longest Day June 21st.

Below is the output from the Sun Calc application, which shows the lines of sunrise and sunset angles at two times of year (longest day June 21st & shortest day December 21st) when low sun would align with the rail approaches and might impact on the sighting.

The thin orange curve is the current sun trajectory, and the yellow area around is the variation of sun trajectories during the year. The closer a point is to the centre, the higher is the sun above the horizon.

The yellow line shows the direction of sunrise; the dark orange line the direction of sunset and the mid orange line the direction at a selected time of day (shown by the orange circle above the satellite image).

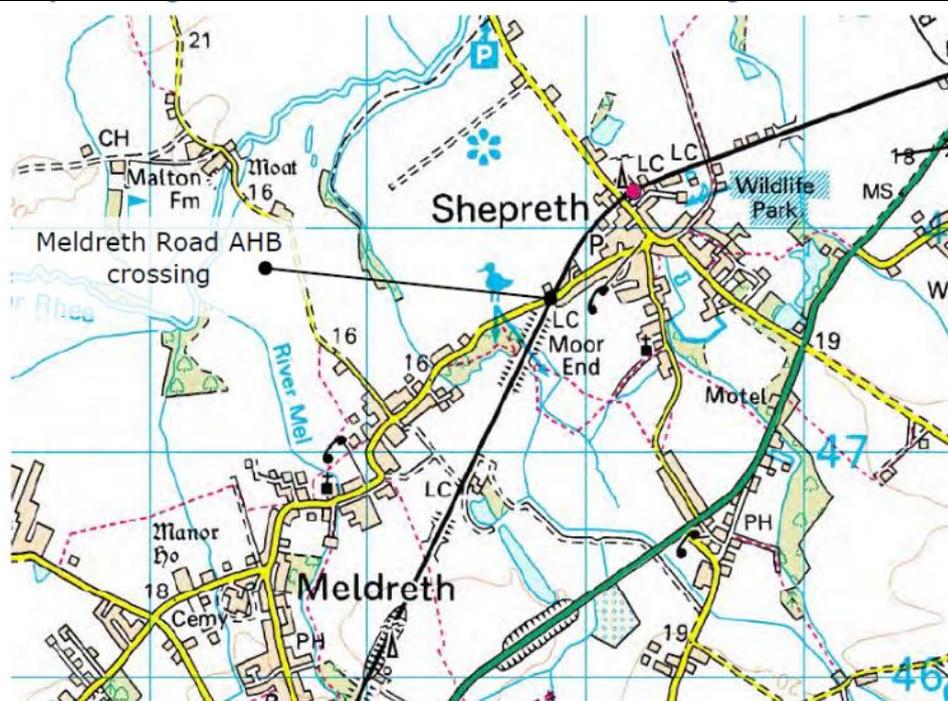
In the satellite view of the crossing below there are a few features that could cause issues which need to be considered within this risk assessment.

- The skew of the crossing relative to the road increasing the chance of vehicles weaving around the barriers.
- Long pedestrian walkways due to the skew of the crossing.
- Residents near the crossing giving rise to the chance of blocking back.
- The absence of pavements either side of the crossing and narrow footways.
- Significant use of cyclists and motorcycles.

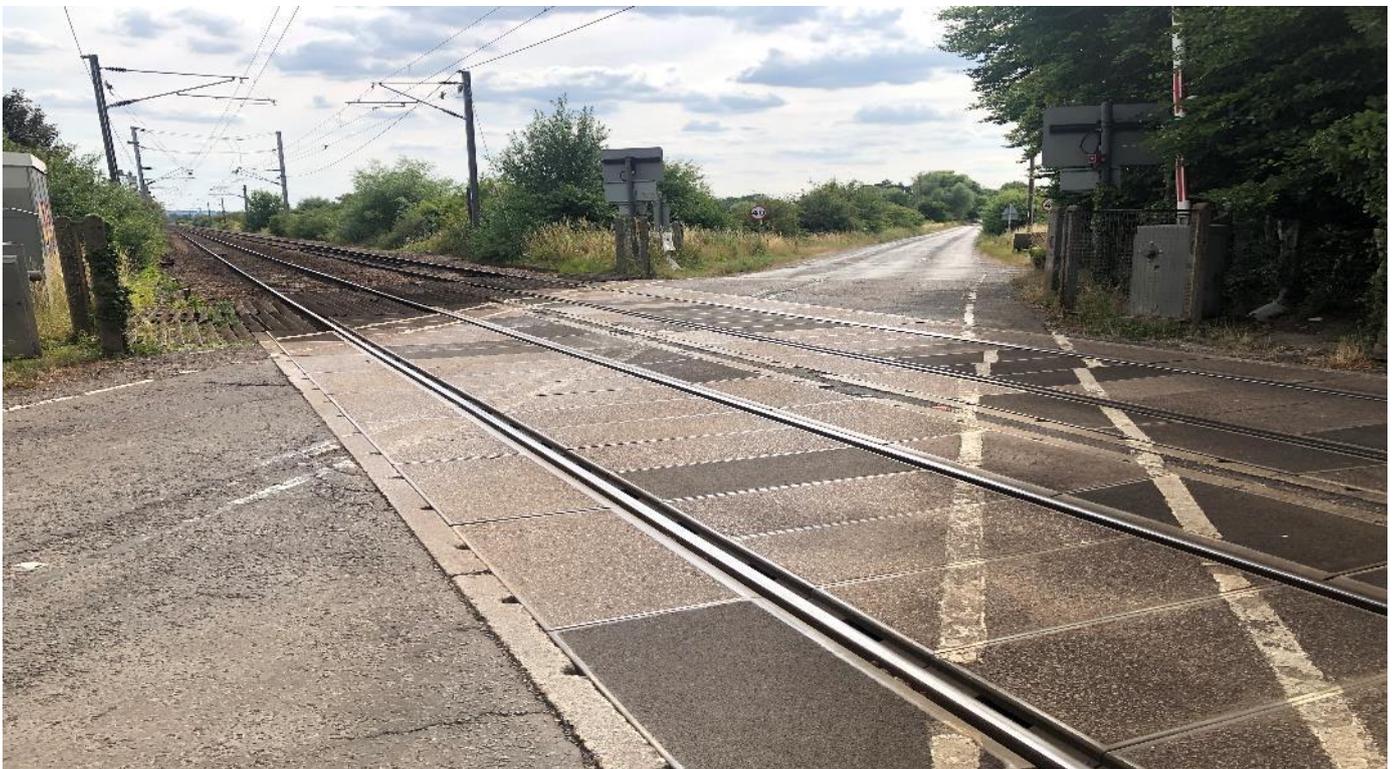
Upside across crossing.

From the west: - The speed limit on the approach to the crossing is the national speed limit (60mph) but there is a speed reduction to 30mph just before the crossing. The 85th percentile road approach speed is 45 mph indicating a moderate to high road approach speed. The measurement point is generally sited at the distant signage where the posted speed limit is still 60mph. The actual speed over the crossing may be lower.

For vehicles traversing the crossing there is a right hand turn into a residence, which could be a source of blocking back although no blocking back was noted during the nine-day traffic census.

The road approach is orientated southwest to northeast at the crossing but there is background shielding to the crossing in the form of vegetation, which will limit the effects of low sun. Indeed, vegetation is beginning to impair the view of the near side RTL (Downside).

At the estimated road speed, the visibility of level crossing signage and equipment on the upside is easily sufficient - a vehicle would have surplus time to react if the crossing is activated

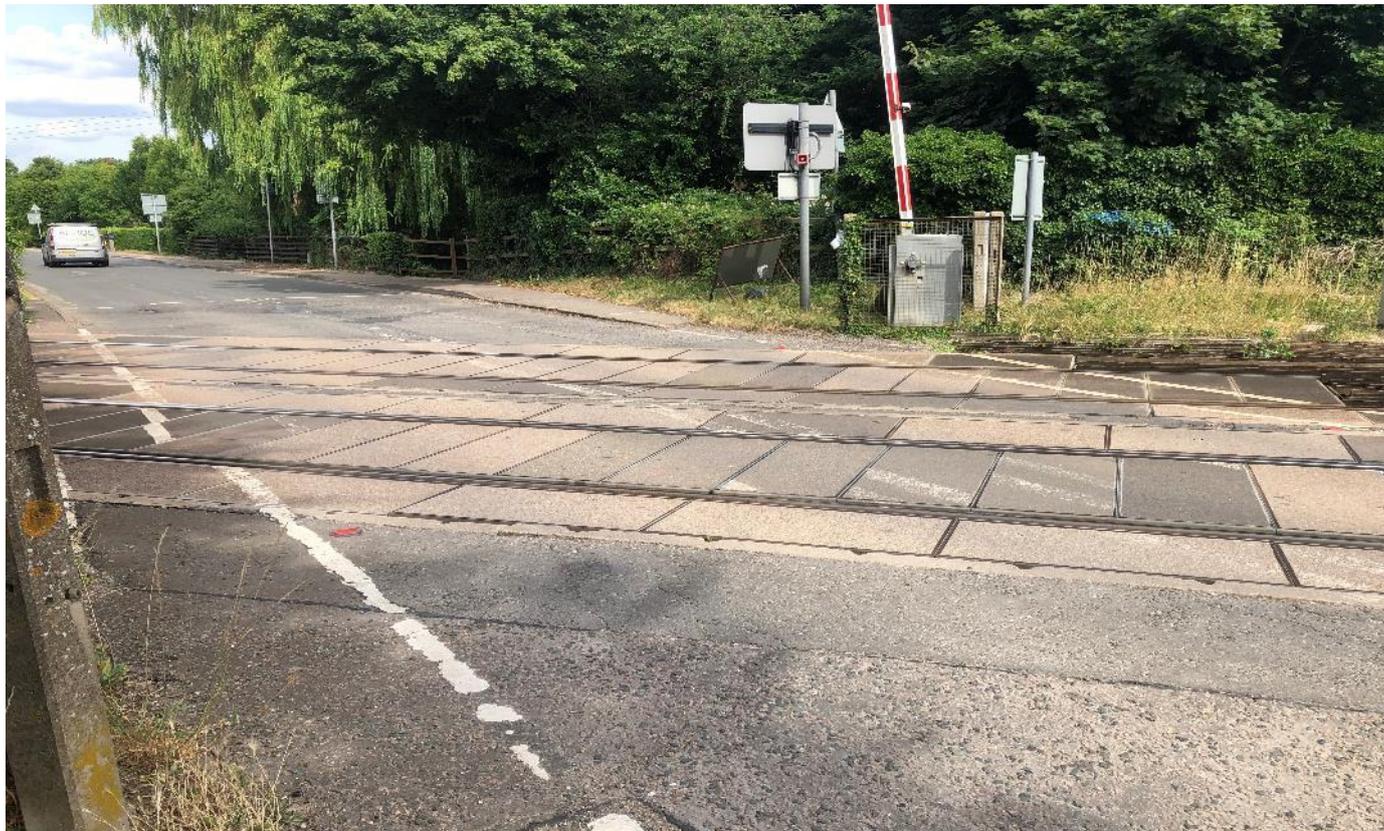
Downside across crossing.

From the east: - Although the road is slightly curved on this approach, it is possible to see the crossing at the distant signage. Vegetation is beginning to impinge on the offside RTL. The road has a speed limit of 30mph and the 85th percentile road approach is 33.1 mph indicating a moderate road approach speed.

There are also no turnings or intersections near to the crossing that are likely to give rise to blocking back.

The road approach is orientated north-east to south-west at the crossing but there is background shielding to the crossing in the form of vegetation, which will limit the effects of low sun.

At the estimated road speed, the visibility of level crossing signage and equipment on the downside is easily sufficient - a vehicle would have surplus time to react if the crossing is activated
